Appendix: Photos of Lead Sources in Drinking Water

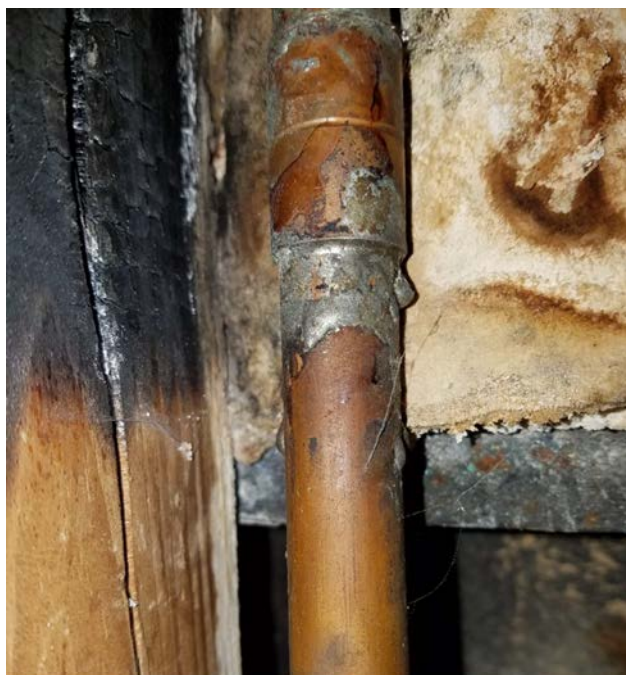
Figure 1: Leaded solder copper joint (photo credit: US EPA/ORD)

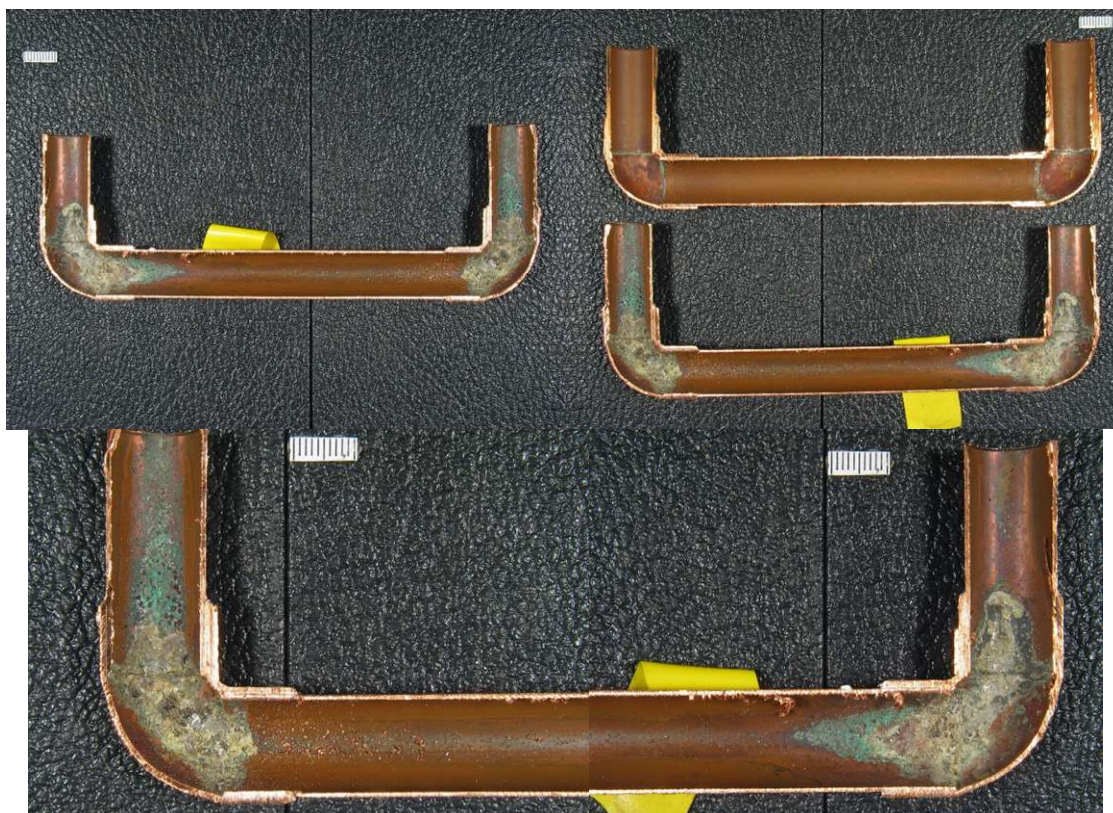
Figure 2: Cross-section views of soldered joints (photo credit: US EPA/ORD)

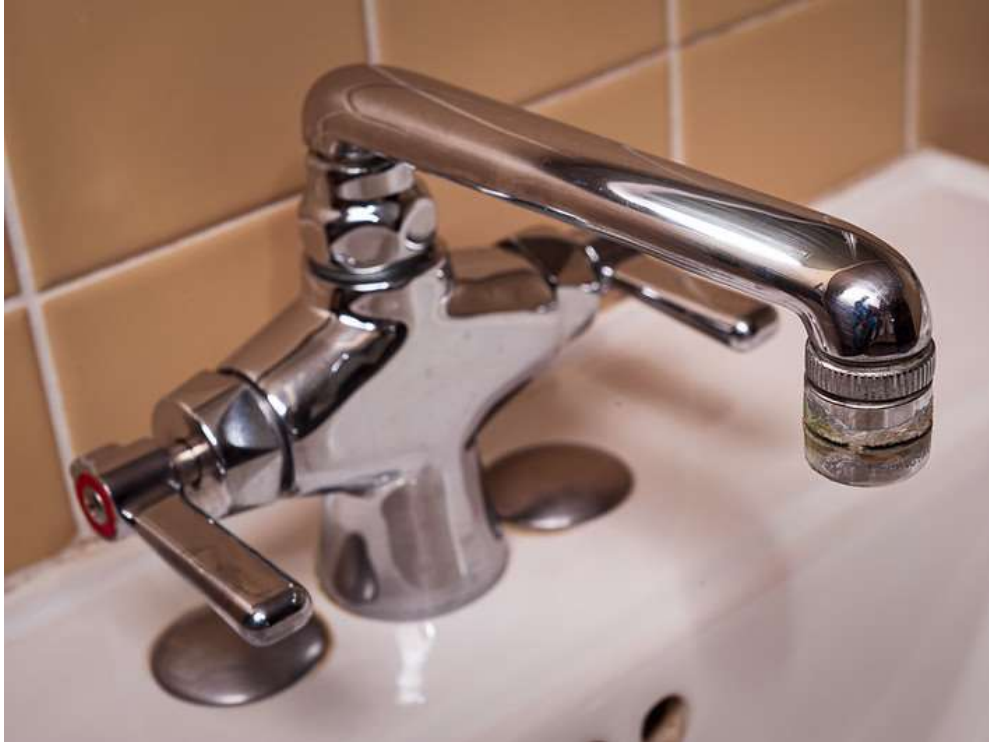
Figure 3: Leaded fitting on a sink faucet (photo credit: US EPA/ORD)

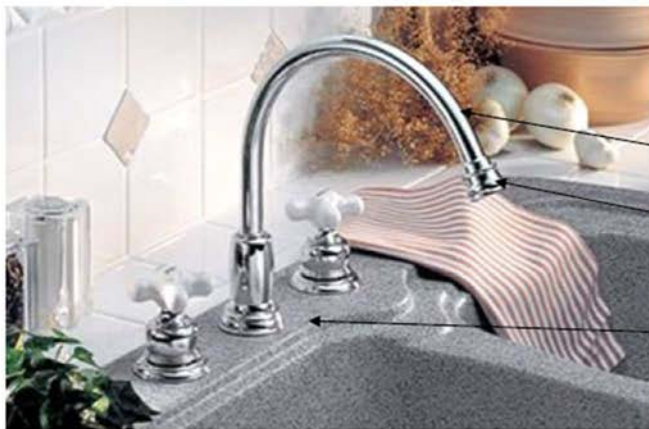
268 Brass Tubing – 0.15% Pb

360 Brass Rod – 3% Pb

Waterway –

Copper Tube – 0% Pb

Tin Plated

Figure 6: Lead content in plumbing fixture (photo credit: Craig Selover)

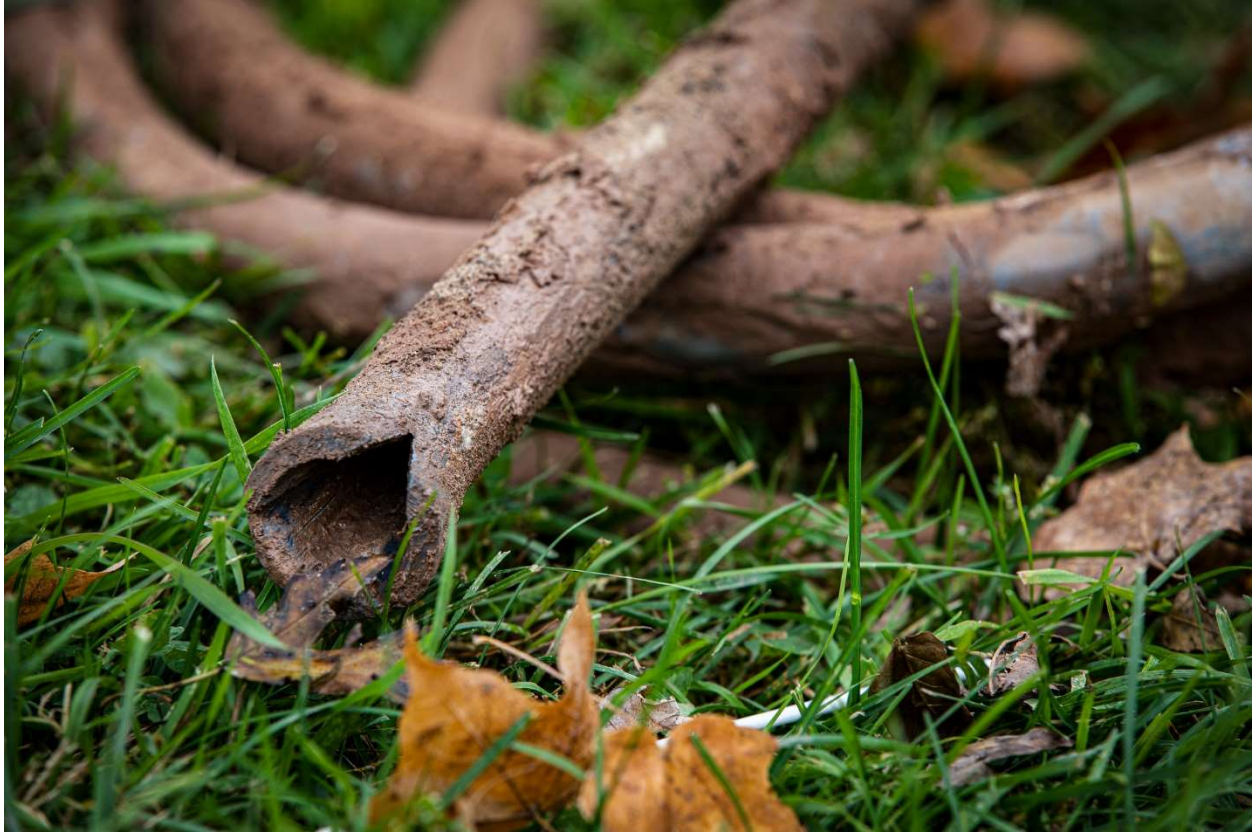
Figure 7: Lead service line (photo credit: US EPA/ORD)
